Cool Roofs in Use in Northern Climates: A Case Study

M. Fenner, Technical Lead Specialist, Target Corporation
M. DiPietro, Product Development Specialist, Sika Corporation --- Roofing
S. Graveline, Vice President Technical Services, Sika Corporation --- Roofing

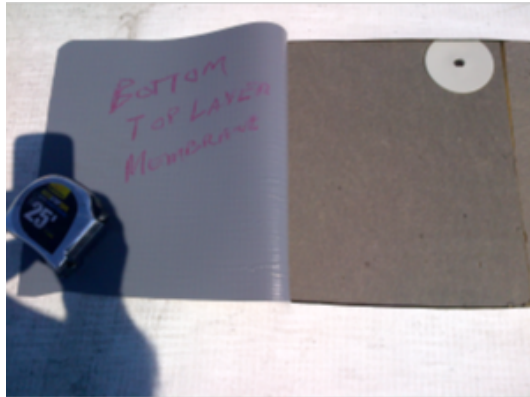
Photo 1: Cheektowaga, NY, Top membrane recover board interface

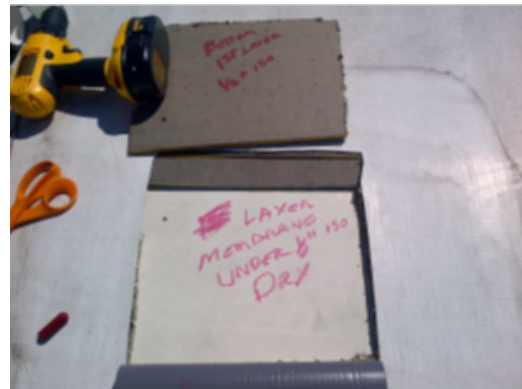
Photo 2: Cover board original membrane interface

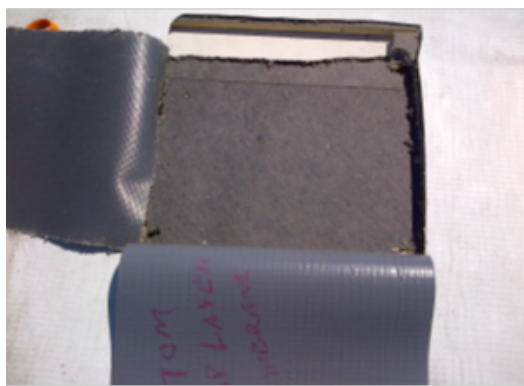
Photo 3: Original membrane insulation interface

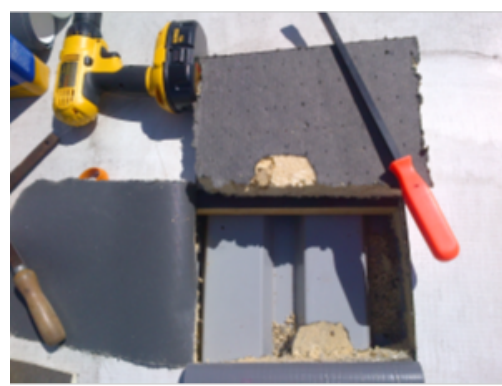
Photo 4: Steel deck

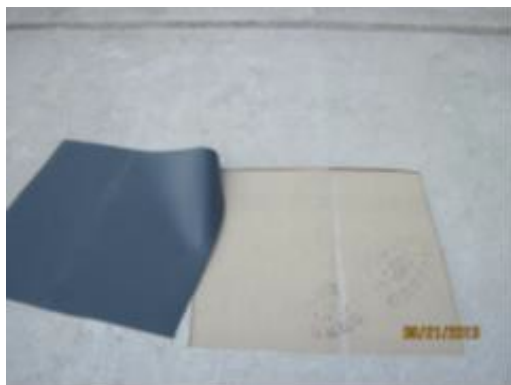
Photo 5: Flint, MI Recover board

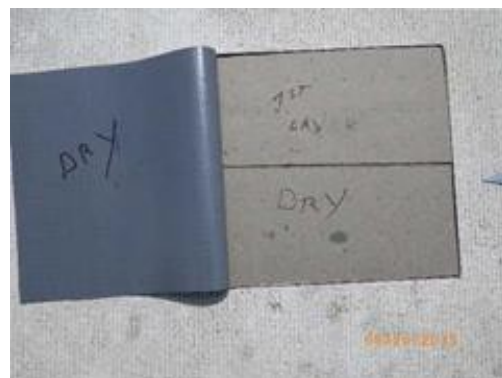
In multi layered systems good practice dictates that joints of adjacent layers should be staggered in order to, amongst other things, eliminate thermal shorts. In all 11 roofs listed in Table 2, this was found to have been done at all cut test locations. In one cut test on a store in Newington, CT both layers of insulation were found to be wet. Further investigation revealed the source of moisture to be leakage into the roofing assembly from an adjacent HVAC unit. Two other cut tests were done in other locations on the roof. No moisture was detected at any roof component interface, nor was any staining or mold or other evidence of deterioration observed in either of these two cuts, or in any of the other cuts taken on the balance of the roofs with multiple board layers. Photos 6, 7, 8, 9, 10 of one of the cut tests done on the Chaska, MN store are typical of what was observed in all locations but the leaking area on the CT store.

Photo 6: Chaska, MN Membrane top layer insulation interface

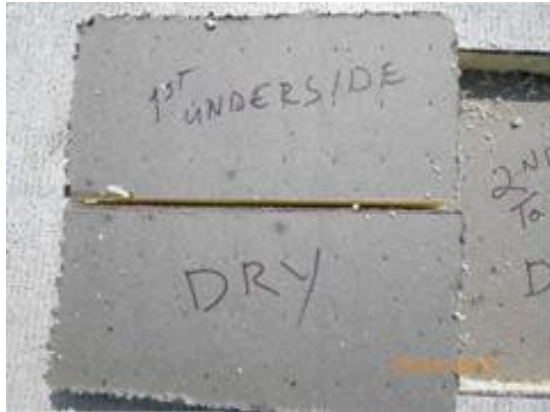
Photo 7: Top insulation underside

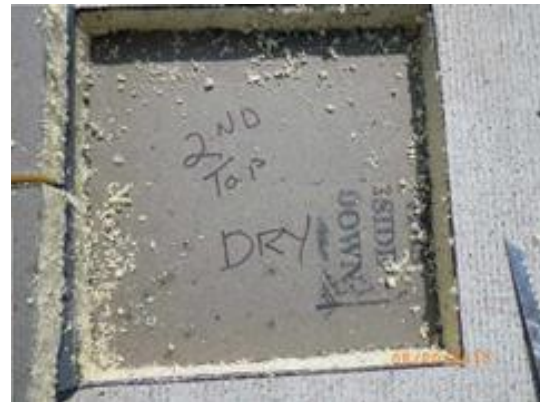
Photo 8: Bottom insulation topside

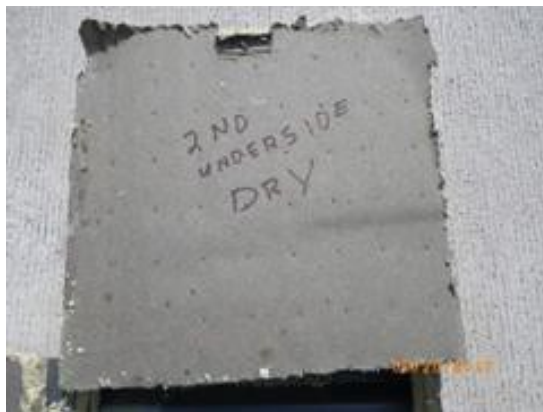
Photo 9: Bottom insulation underside

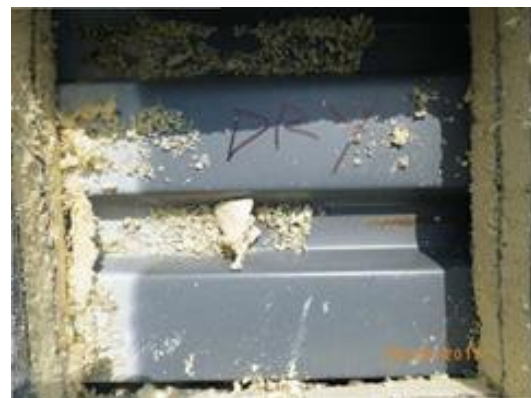
Photo 10: Steel deck

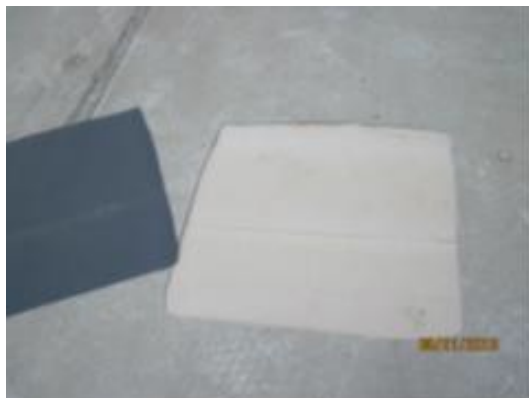
As shown in Table 1, 11 of the roofs investigated had a single layer of insulation, which depending on the location was typically 2" or 3" thick. Photos 11, 12 of one of the cut tests from the Novi, MI store provide a typical representation of the observations made in all stores. No moisture was detected nor was any staining or deterioration of any kind seen in any these 11 roofs ranging in age from approximately 10 to 13 years old, located in the states of MA, MI, MN, NY and WA.

Photo 11: Novi, MI Membrane insulation interface

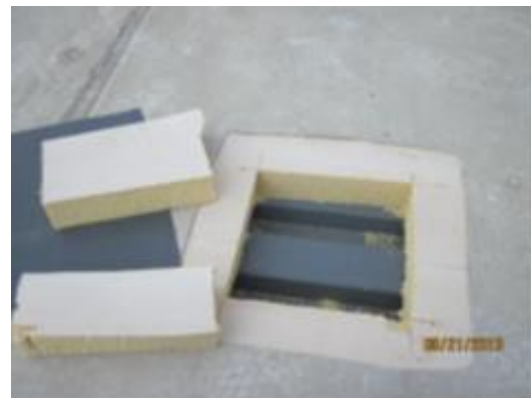
Photo 12: Insulation underside, deck

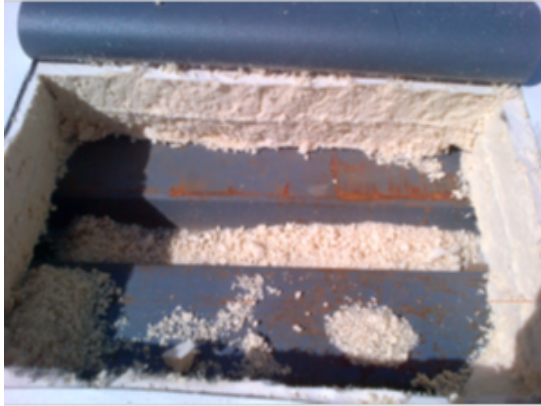
With two exceptions, the steel decks observed in the other 51 openings (2 per roof except Newington, CT, which had three) were in very good condition. In the location of the leak in the Newington, CT store the top surface of the steel deck flutes was rusted over the entire contact area with below the wet insulation. The rust transferred to the underside of the bottom insulation layer. On the Poughkeepsie, NY store localized rust (Photo 13) was observed on the top flange of the deck in one of the cut tests. As no rust stains were observed on the underside of the insulation in this location (Photo 14), it is assumed that the rust had formed prior to the installation of the roof assembly. There was no evidence of rust in the second cut test location.

In the balance of the cuts, random, superficial corrosion of scratches or minor abrasions, often at the vertical to horizontal bend at the top of flutes, was seen in some locations. These observations were consistent with the surface damage which typically occurs during steel deck installation, and the minor amount of rust had likely formed before the roof was installed. This hypothesis is supported by the lack of rust stains on the back of the insulation in these locations.

Photo 13: Poughkeepsie, NY Localized rust on deck

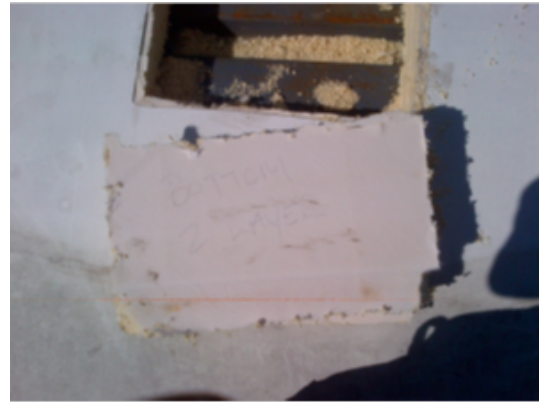
Photo 14: Insulation underside
