# CASE STUDY COOL ROOFS in Use in Northern Climates

by michael fenner, michael dipietro and stanley graveline

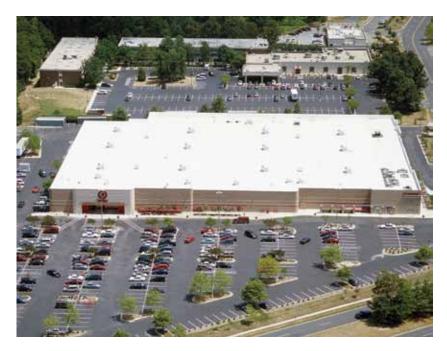
Tests were conducted on the roofs on 26 Target stores located throughout the states of Connecticut, Illinois, Massachusetts, Michigan, Minnesota, New York, Washington and Wisconsin. Photos courtesy of Target Corporation and Sika Sarnafil.

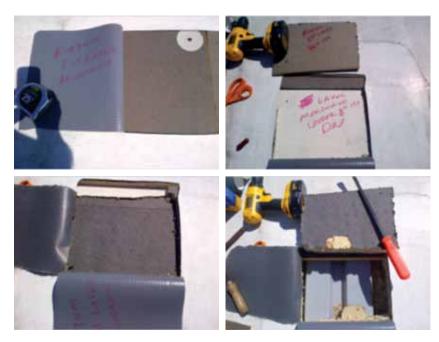
(TOP LEFT) PHOTO 1: Cheektowaga, N.Y., top membrane recover board interface. (TOP RIGHT) PHOTO 2: Cover board original membrane interface. (BOTTOM LEFT) PHOTO 3: Original membrane insulation interface. (BOTTOM RIGHT) PHOTO 4: Steel deck.

The four roofs were recovers of EPDM and PVC roofs. Photos 1, 2, 3, 4 taken of a cut test on the Cheektowaga, N.Y., store was typical of all four. No evidence of moisture was detected in any of these assemblies, neither between the new and old membrane. nor below the original membrane. The only notable staining observed was a small section along one edge of an insulation board on the Flint, Mich., store. The fact that no staining was observed on the adjacent board (or in the second cut), and additionally that a boot print was super imposed over the stain (Photo 5) would indicate that the edge of that particular panel had been wetted prior to being installed. It is interesting to note that there was no difference in the appearance of the insulation below the original roof between the "cool" PVC and "non-cool" black EPDM roofs.

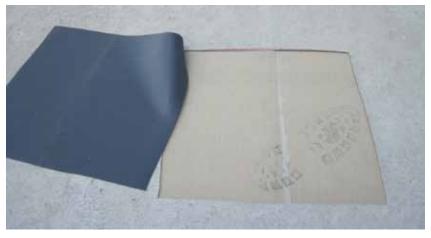
PHOTO 5: Flint, Mich., recover board.

new mechanically fastened membrane was installed. This approach diverted approximately 25,000 cubic feet of material from being landfilled on a typical store re-roof. Four such roofs were part of the survey. In three of them a gypsum-based cover board had been installed, in the fourth a 1/2-inch layer of iso had been used.

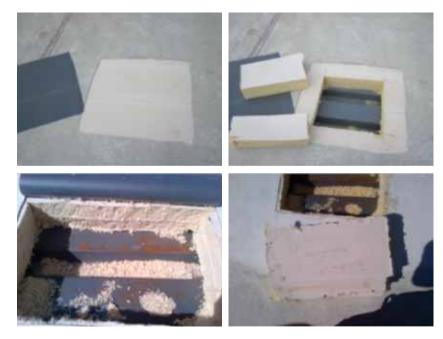
As shown in Table 1, 11 of the roofs investigated had a single layer of insulation, which depending on the location was typically 2 inches or 3 inches thick. Photos 6 and 7 of one of the cut tests from the Novi, Mich., store provide a typical representation of the observations made in all stores. No moisture was detected nor was any staining or deterioration of any kind seen in any these 11 roofs ranging in age from approximately 10 to 13 years old, located in the states of Massachusetts, Michigan, Minnesota, New York and Washington.

(TOP LEFT) PHOTO 6: Novi, Mich., membrane insulation interface. (TOP RIGHT) PHOTO 7: Insulation underside, deck. (BOTTOM LEFT) PHOTO 8: Poughkepsie, N.Y., localized rust on deck. (BOTTOM RIGHT) PHOTO 9: Insulation underside.

over the entire contact area below the wet insulation. The rust transferred to the underside of the bottom insulation layer. On the Poughkepsie, N.Y. store localized rust (Photo 8) was observed on the top flange of the deck in one of the cut tests. As no rust stains were observed on the underside of the insulation in this location (Photo 9), it is assumed that the rust had formed prior to the installation of the roof assembly. There was no evidence of rust in the second cut test location.
