Project: Park on Main Project

Location: Norman, Oklahoma

Contractor: Mallard Roofing

Products: IB Roof Systems and flooring tiles

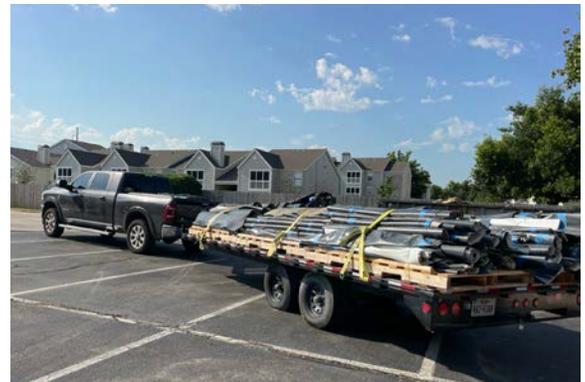
Just three months old, the mechanically fastened system’s PVC (vinyl) membrane survived the onslaught intact, but the underlying substructure, including cover boards and insulation, were compromised. Fortunately, the supreme recyclability of the PVC roofing membrane rescued what could have been a disastrous situation.

The substructure needed to be replaced, so the roofing membrane had to come off, even though it was fine. Because removal entails cutting the roofing membrane into strips, it couldn’t be re-used on this same project. It could, however, be collected, recycled, and turned into something else.

The company carefully collected the 80,000 square feet of PVC membrane and sent it to a recycler located in South Carolina. The IB Roof Systems team cut the membrane into approximately yard-wide strips and rolled them (necessary for any removal), then placed the rolls on pallets and loaded the pallets onto a truck bound for the recycler.

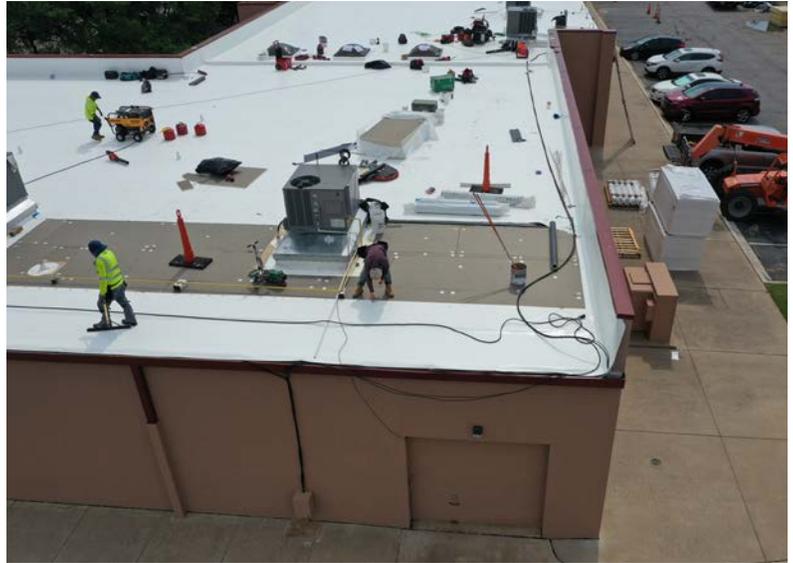
Hail is potentially damaging to all roofing material, especially at the near-baseball size seen here. Fortunately, due to PVC's recyclability and quick thinking by the people of IB Roof Systems, they kept 80,000 square feet of material from ending up in a landfill. ■
